MIM Construction AB  
Myren 125  
460 64 FRÄNDEFORS

## Test of Variocage III Double M, dog crate according to the SPCT-method, Revision 2

The Variocage III Double M, dog crate from MIM Construction has been tested according to the SPCT-method<sup>1</sup>, Revision 2.

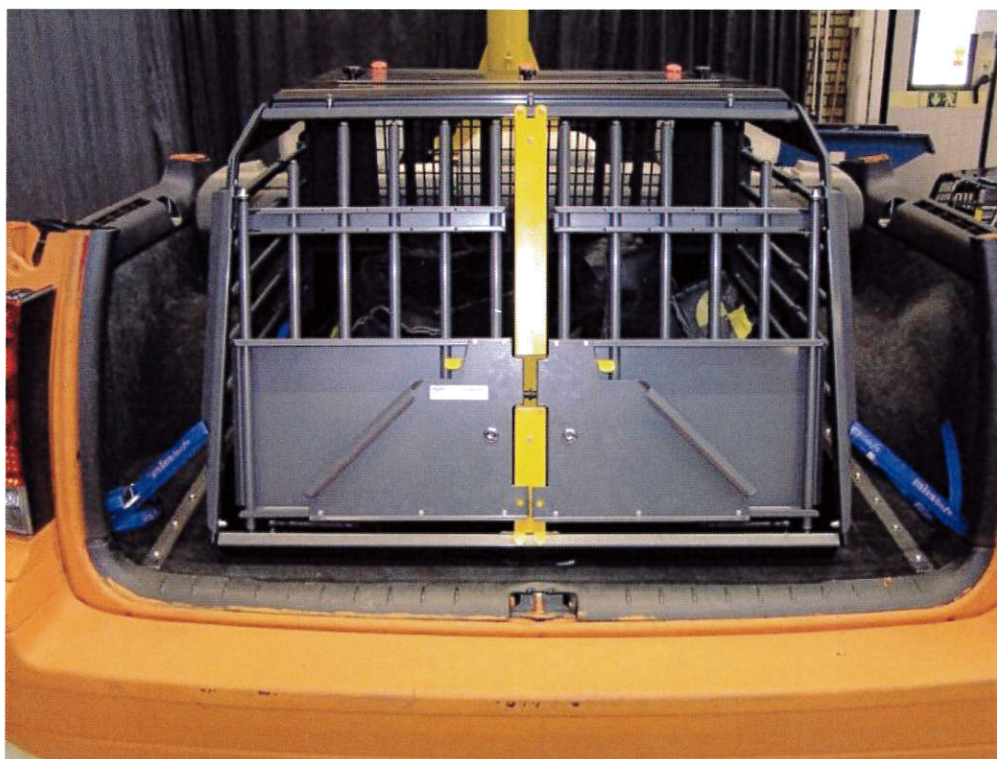
The dog crate was positioned in the luggage compartment of a Volvo V70N chassis with a backseat divided in 40/60 and made of aluminium, see figure 1.  
The sled was accelerated to a speed of 48.6 km/h before impact.

Figure 1 Test setup Frontal impact crash test

During the frontal impact the rear left attachment strap was cut off. The rear right strap attachment in the dog crate broke. The dog crate was still attached by the two front attachments.

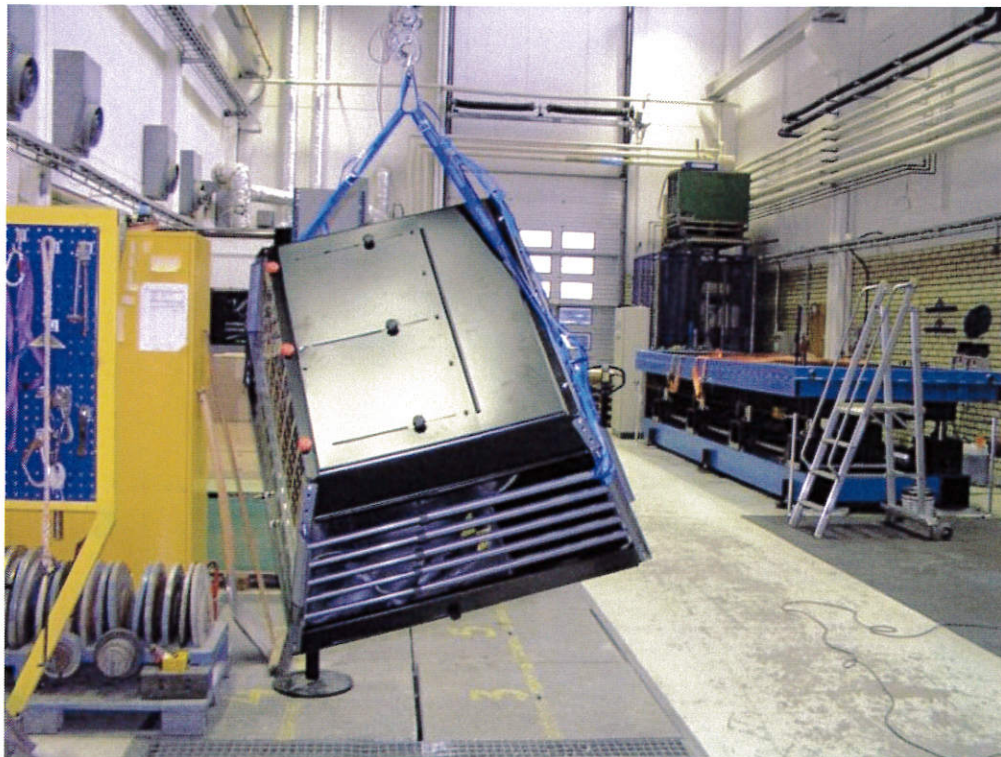
Test object position: Longitudinal axle 45°  
Transverse axle 15°  
70 cm above drop plate

The test object was mounted in a drop test rig. The impact position was adjusted with straps and rotated around the vehicle's prospective longitudinal axis 45° and then turned around the vehicle transverse axis of drafting 15°. The lowest point of the test object was adjusted to 70 cm above the drop plate, see figure 3.

Figure 3 Test setup Drop test

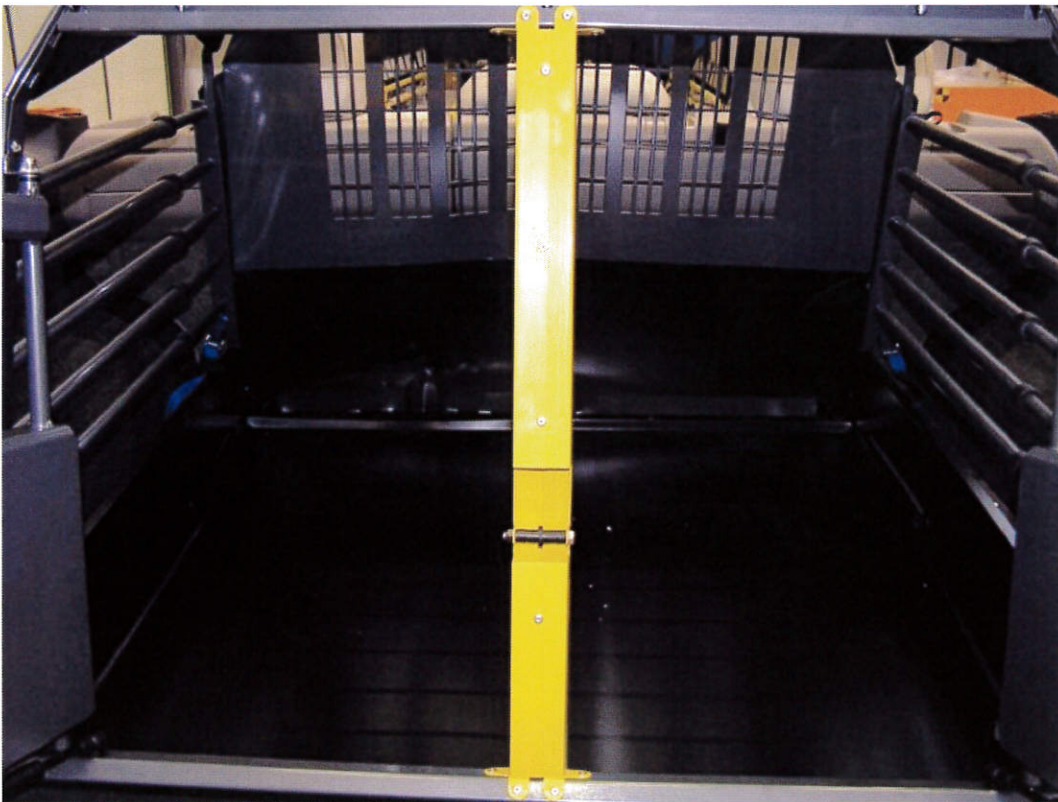
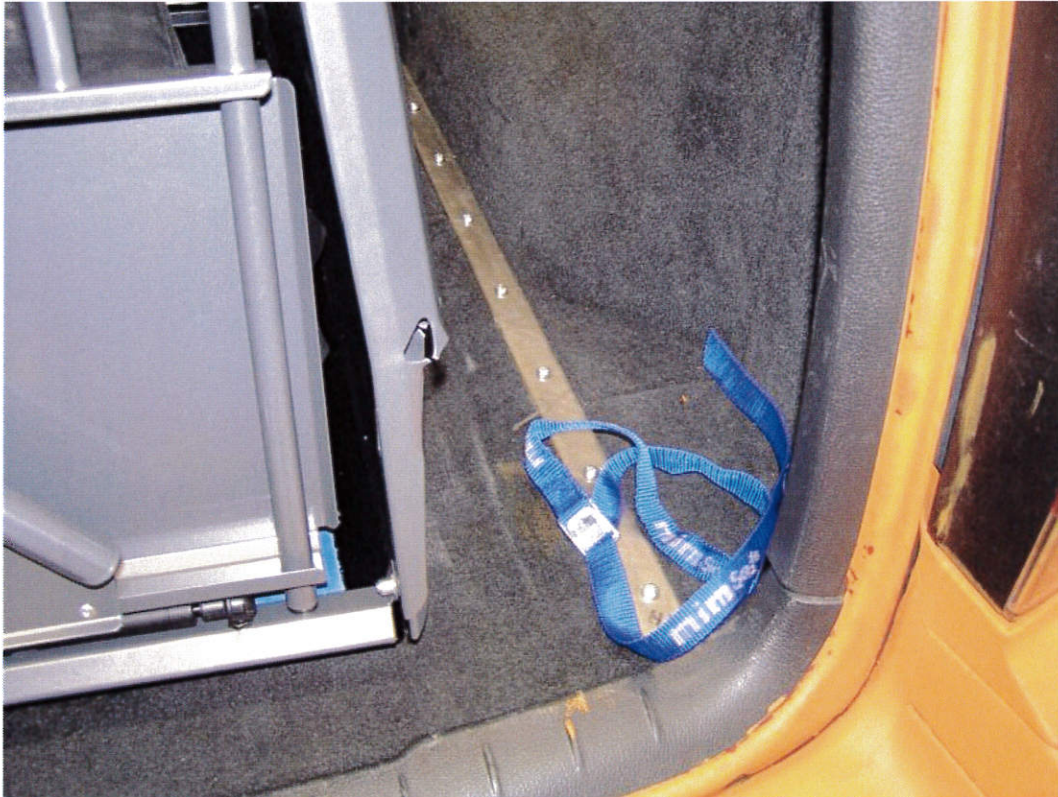
04 – After test, frontal impact

05 – After test, frontal impact

06 – After test, frontal impact

07 – After test, frontal impact

08 – After test, frontal impact
